Burnaby Stone Care Ltd.

Marks and Spencer's flagship Liverpool City Centre Store

Volume 1 Issue 2

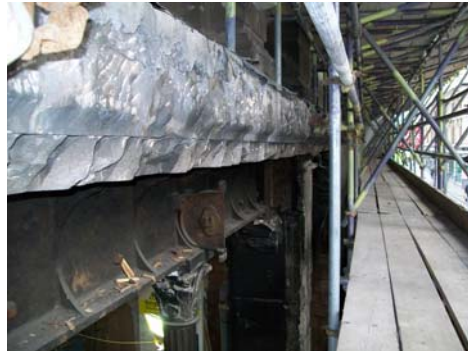
Existing cornice prior to preparation to receive new stonework

Works to date have included liaising with the Conservation Officer and Client to agree a scope of works with ourselves, then undertaking stone design and procurement, stone installation, re-pointing works combined with the careful cleaning of the building's ornate façade.

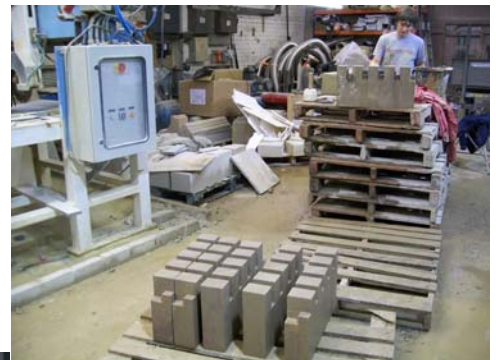
Stone dentils in production

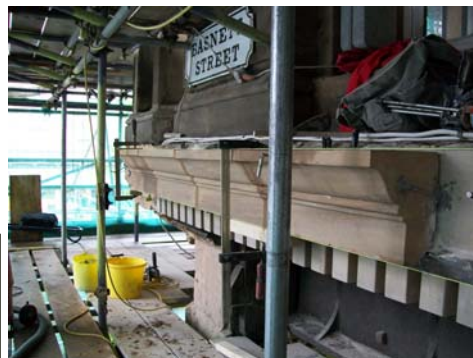
Works in progress —
Cornice/dentils being fixed to existing structure

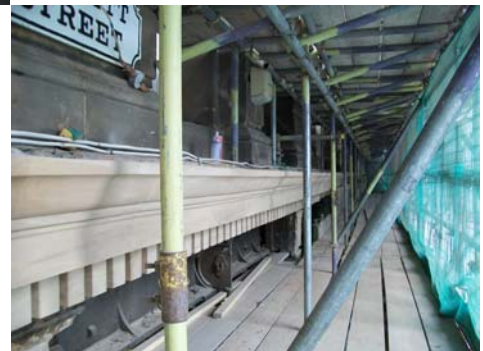
Stone cornice/dentils fixed back to existing structure

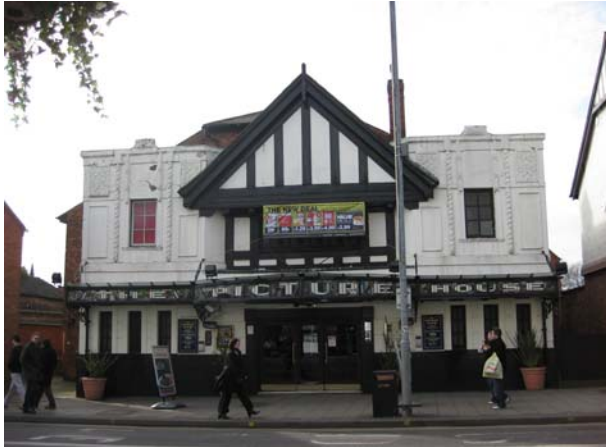
Before Restoration

Works included securing existing rendered panels for stability, removing dilapidated render and renew with a specified lime render to original detailed design profiles, leaving in a near original condition.

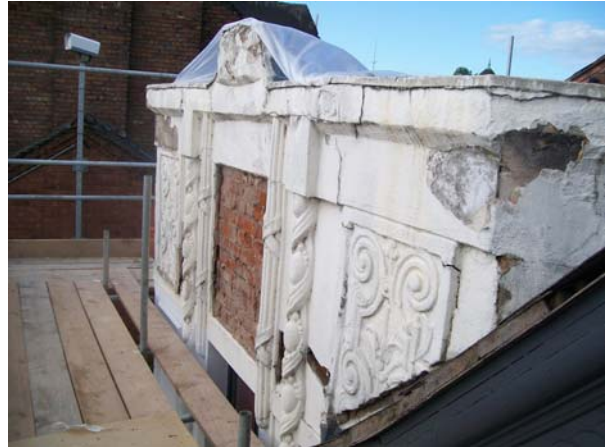
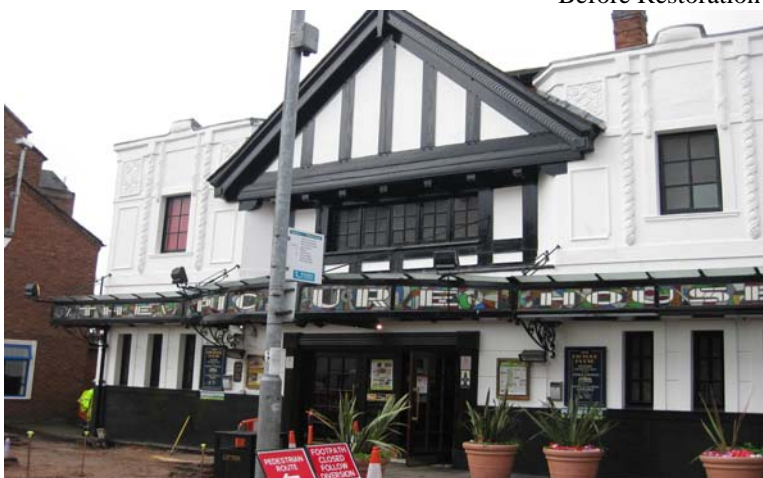
After Restoration

We have now completed restoration works to The Picture House

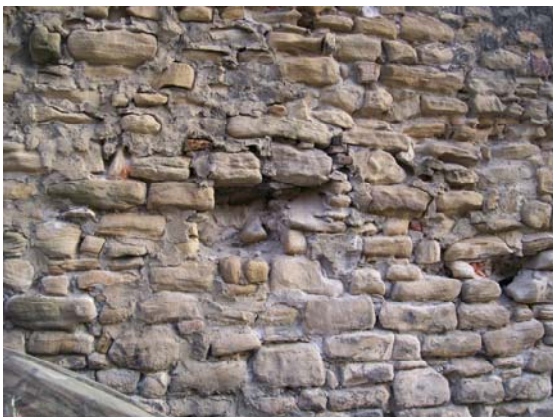
Burnaby Stone Care were asked to carry out re-pointing works to this prominent bar located on the Tyne Waterfront. However, a colony of bats living amongst the random stone walling combined with large areas of missing and defective masonry made restoration works more challenging than on first inspection. We were able to cut back by hand all friable mortar, inserting sections of locally sourced stonework to fill the many large voids whilst stabilising the wall in the process. We then re-pointed utilising a traditional lime mortar, with a brushed-back finish exposing the mortars fine aggregate.

Before Restoration

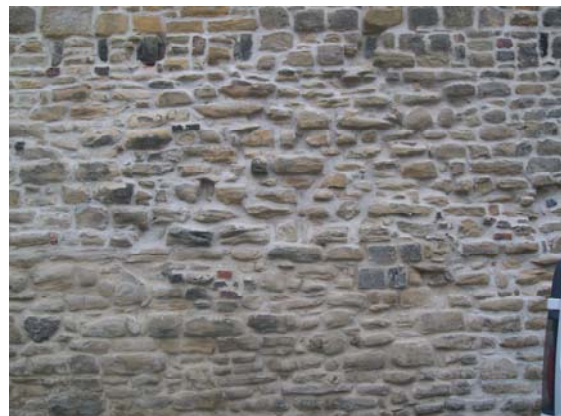
After Restoration

Finally, and most importantly, we gave the bats living behind the stonework new openings in which they could enter or exit their home!
