# Burnaby Stone Care Ltd. Newsletter

## Completion of Marks and Spencer's flagship Liverpool City Centre Store

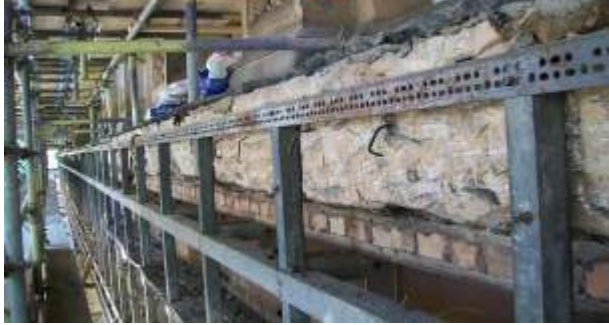
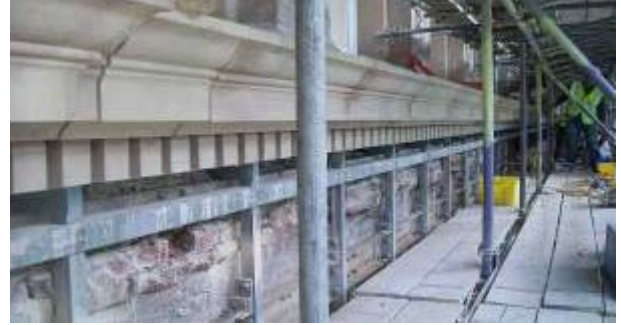
Before

After

80 linear metres of decorative cornice and dentil course replacement to the shop fronts

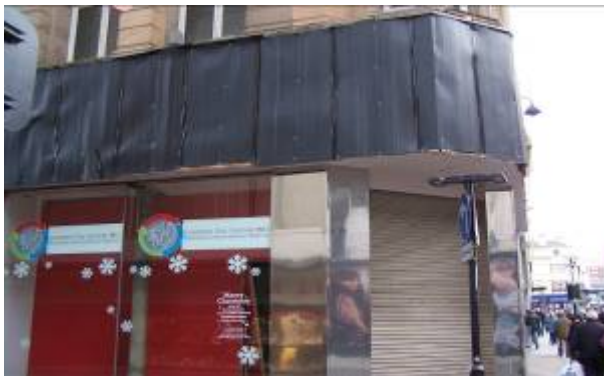
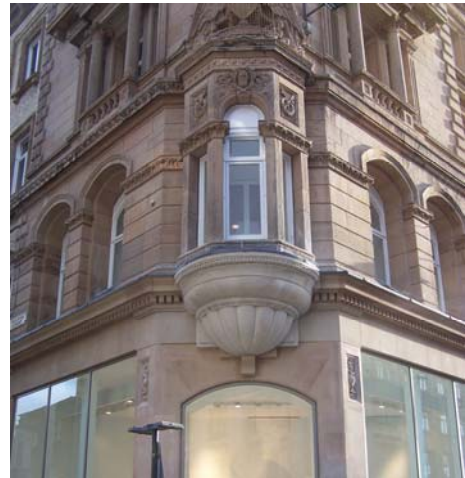
Before

After

Extensive stone replacement and restoration to the oriel windows on either corner of the building
