Burnaby Stone Care Ltd.

Newsletter

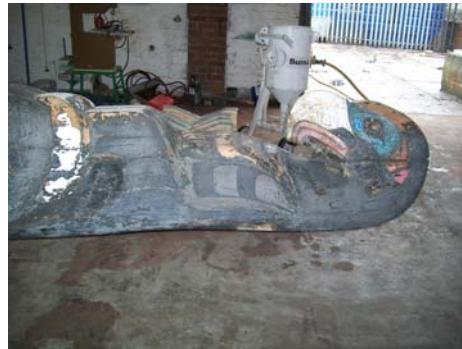
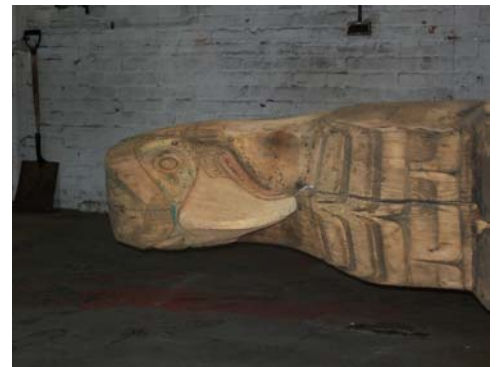
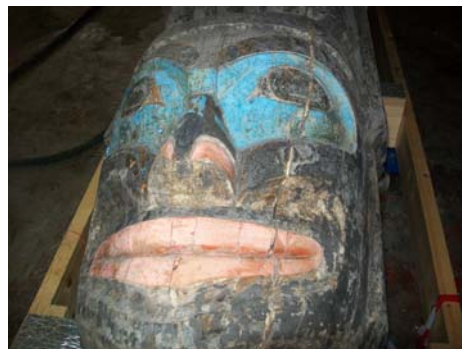
Totem Pole, Salford

We have now completed our part in the restoration to Salford's totem pole. Shipped over in 1969 the 32 foot high pole stood outside Manchester Liners Headquarter for over 30 years and is a symbol of friendship between Manchester and Canada. Over recent years the pole fell into disrepair and had been stored in a disused warehouse.

Burnaby Stone Care have carried out the delicate task of removing layers of unsuitable paint utilising a low-pressure (7 p.s.i.) fine abrasive, specially developed by ourselves, to prevent damage to the underlying wood.

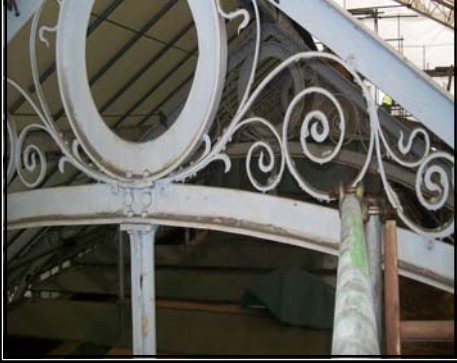
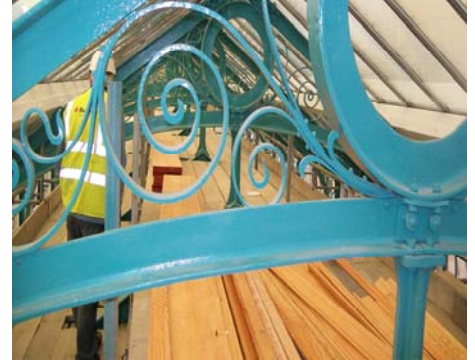
Victoria Baths, Manchester

Winner of the popular BBC programme, Restoration, Victoria Baths has been undergoing re-

storative repairs to the Gala Pool roof.

Burnaby were asked to carry out the cleaning, priming and decorative top coat to the intricate cast iron roof, which as you can see has now been completed successfully.

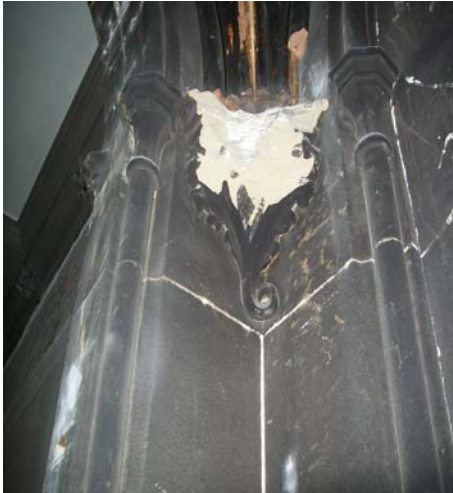
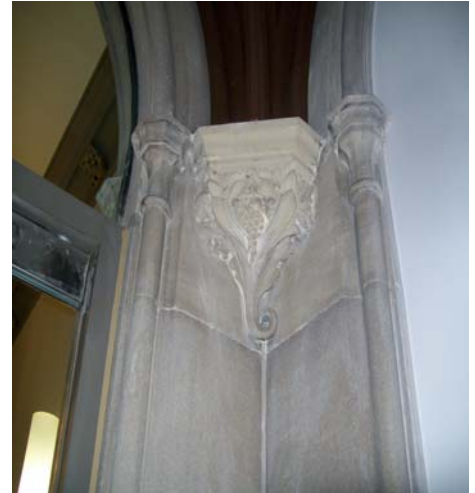
Queen's Chambers, John Dalton Street Manchester

Cleaning and stone repairs have now been completed to internal decorative arches at the above.

Following a fire Burnaby were asked to carry out smoke-damage removal works and also stone carving and indentation to return the sandstone to its former condition.

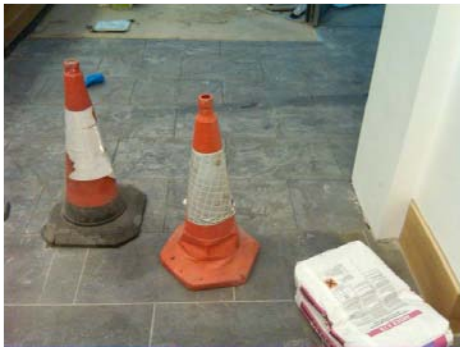
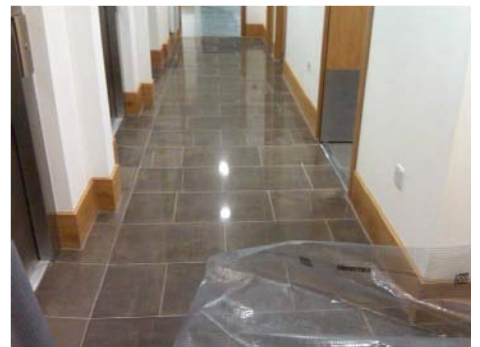
Peel Court, Atkinson Street, Manchester

Works have now been completed to Peel Court, Spinning Fields, Manchester, for the polishing and sealing to all nine floors in this new-build office development. As you can see the results we have been able to achieve are impressive.
